# **Space Shuttle Independent Assessment Team**

Report to Associate Administrator  
Office of Space Flight

October - December 1999

March 7, 2000

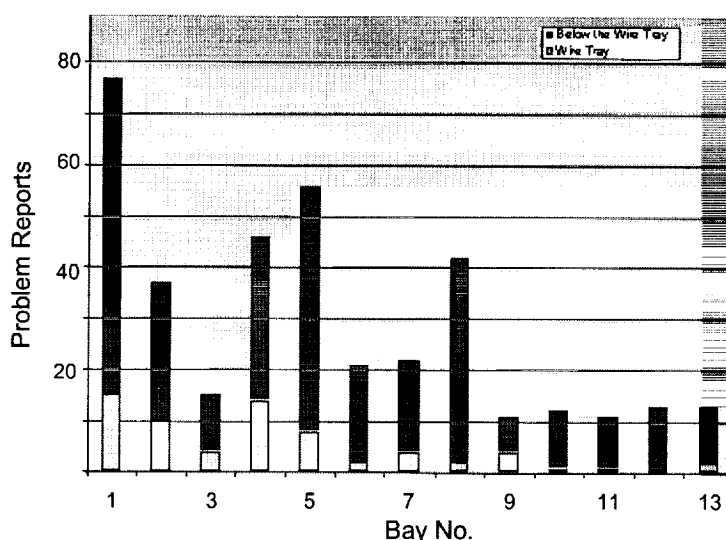
Figure 6 -- Kennedy Space Center Wiring Trending

In addition to assessing general trending capabilities, two trending studies made with data in the Kennedy Space Center and Marshall Space Flight Center Problem Resolution and Corrective Action systems were examined in detail. The first such study concerned wire damage problems. In order to assess the root cause of wire damage, trends were needed that distinguished the type of wire damage (i.e., insulation damage, exposed conductors, conductor damage) as a function of location of occurrence in the Shuttle. An example trend report is shown in *Figure 6 -- Kennedy Space Center Wiring Trending*. To provide this information, a team of 10 engineers and 3 quality inspectors worked for 1 week reviewing Problem Reports in the Kennedy Space Center Problem Resolution and Corrective Action system. This intense effort was needed because the data contained in the system lacked standardization and fidelity and needed to be assessed and interpreted by the engineers in order to be meaningful. In some cases, the data did not exist or could not be resurrected.

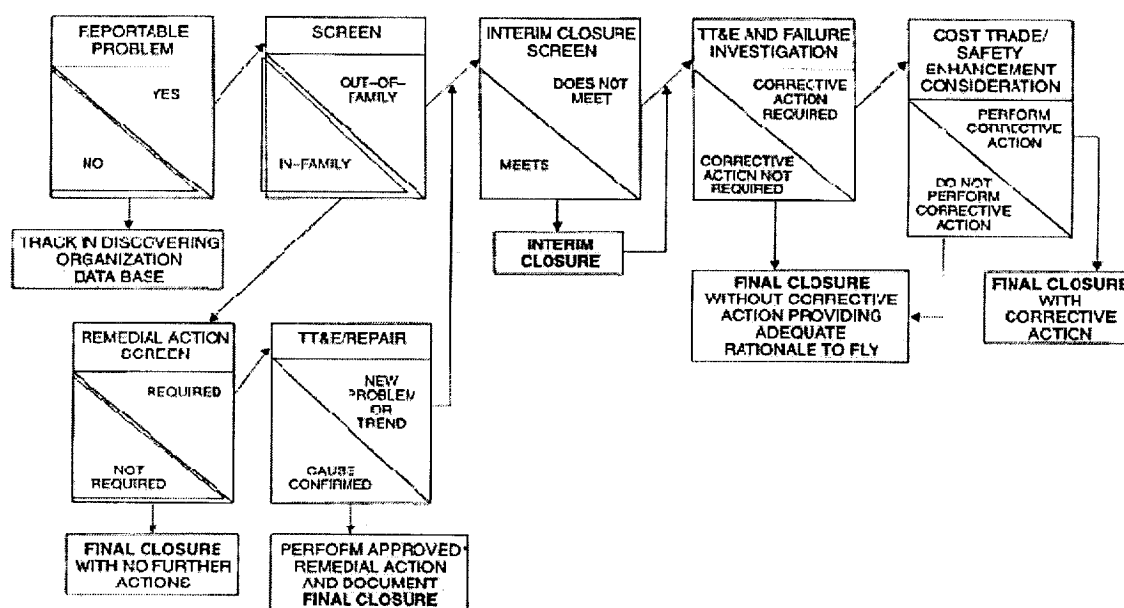
Figure 7 -- Problem Processing & Dispositioning

Problem processing procedures were also examined for potential weaknesses. It was found that several decision points (see *Figure 7 -- Problem Processing & Dispositioning*) exist in the procedures in which a problem and important attendant information can fail to enter the Problem Resolution and Corrective Action system. First, a problem has to be judged reportable, a judgment subject to the problems of uncertainty, interpretation, and lack of information described above. Decisions concerning problem reportability may occur at the technician level, with little engineering and/or Safety & Mission Assurance oversight or review.

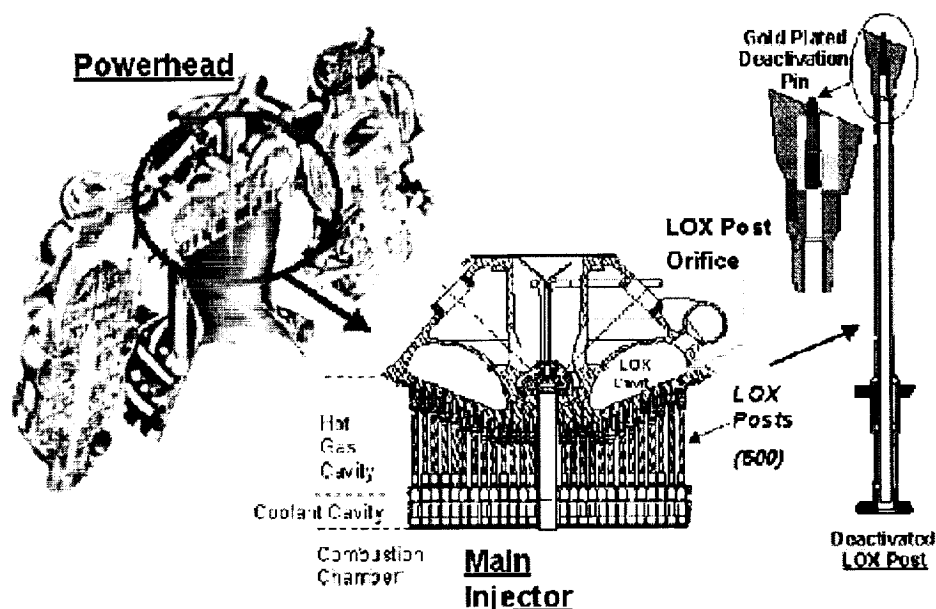
Figure 14 -- Powerhead, Main Injector and Liquid Oxygen Post Details

It has been common practice to deactivate Main Injector Lox Posts, when they are determined to be life limited because of manufacturing or operational damage. When a post life limit is reached, a pin is inserted in the liquid oxygen post supply orifice (*Figure 14 – Powerhead, Main Injector and Liquid Oxygen Post Details*). The pin shuts off the liquid oxygen flow through the post, reducing high cycle fatigue loading. The tapered pin is about 1" long, 0.100 inches in diameter, gold coated, and is pressed with interference fit into the orifice.

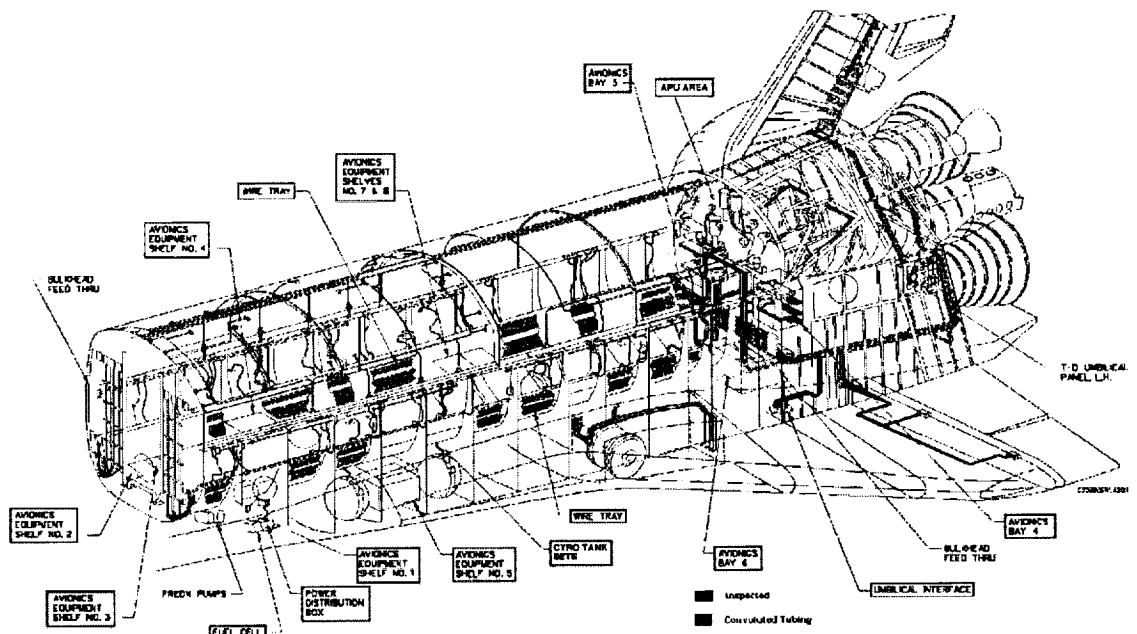
Figure 26 -- Inspected Areas

Inspectors have been encouraged not to conduct intrusive inspections to minimize induced wire damage. The most intense inspection has been conducted in the mid-body bays. A summary of the areas inspected in the mid-body and aft areas is shown graphically in . An examination of the Problem Resolution and Corrective Action system data prior to recent inspections shows the mid-body area to be the fourth highest area with wire damage (*Figure 30*). The data as of November 18, 1999 shows that since the recent inspections in late August 1999, there have been 485 PRs written related to wiring in the mid-body area (see Table 4). Examples of the type of wire damage being found are shown in *Figure 23* and *Figure 24*. Note that in *Figure 23* the conductor is exposed and has broken strands.

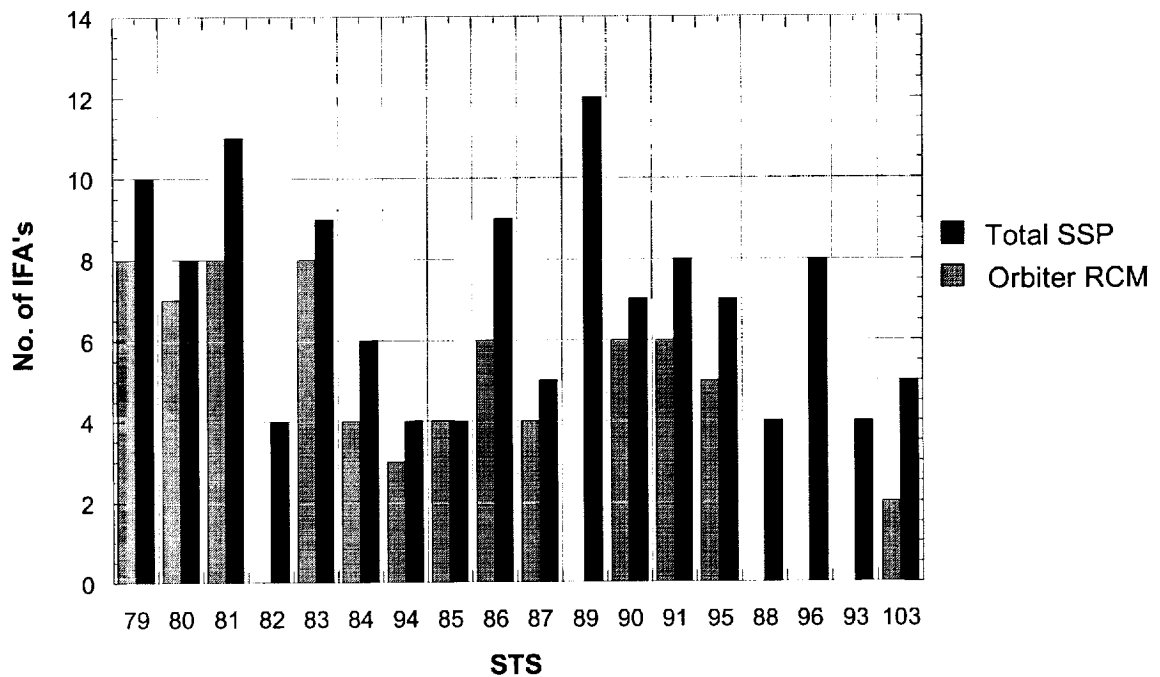
Figure 35 -- Space Shuttle In-Flight Anomalies

The SIAT did not identify a single, ideal metric in the information presented by the SSP to indicate the effects of aging and the adequacy of maintenance efforts in addressing these effects. IFA's (see *Figure 35*) were used as an indication of how many actual problems develop during flight that may affect flight safety and mission completion. The number of Problem Reports generated during Shuttle maintenance periods was also examined (see **Problem Reporting & Tracking Process**); however, PR generation is affected by a number of factors, including the number of inspectors and inspection points and the adherence to reporting procedures, that may obscure the number of actual problems. A third metric, the history of open Corrective Action Reports (CAR's) was studied as well (see *Figure 36*). The number of open CAR's is indicative of both the number of problems and the effectiveness of the resolution process. Missing from all three indicators is explicit information concerning the severity of the problems. As a consequence, some combination of these metrics (and others) should be examined, with the appropriate analyses to identify the true trends and their root causes.
